NATIONAL ADVISORY COMMITTEE
FOR AERONAUTICS

TECHNICAL NOTE 1938

MECHANISMS OF FAILURE OF HIGH NICKEL-ALLOY
TURBOJET COMBUSTION LINERS

By John W. Weeton

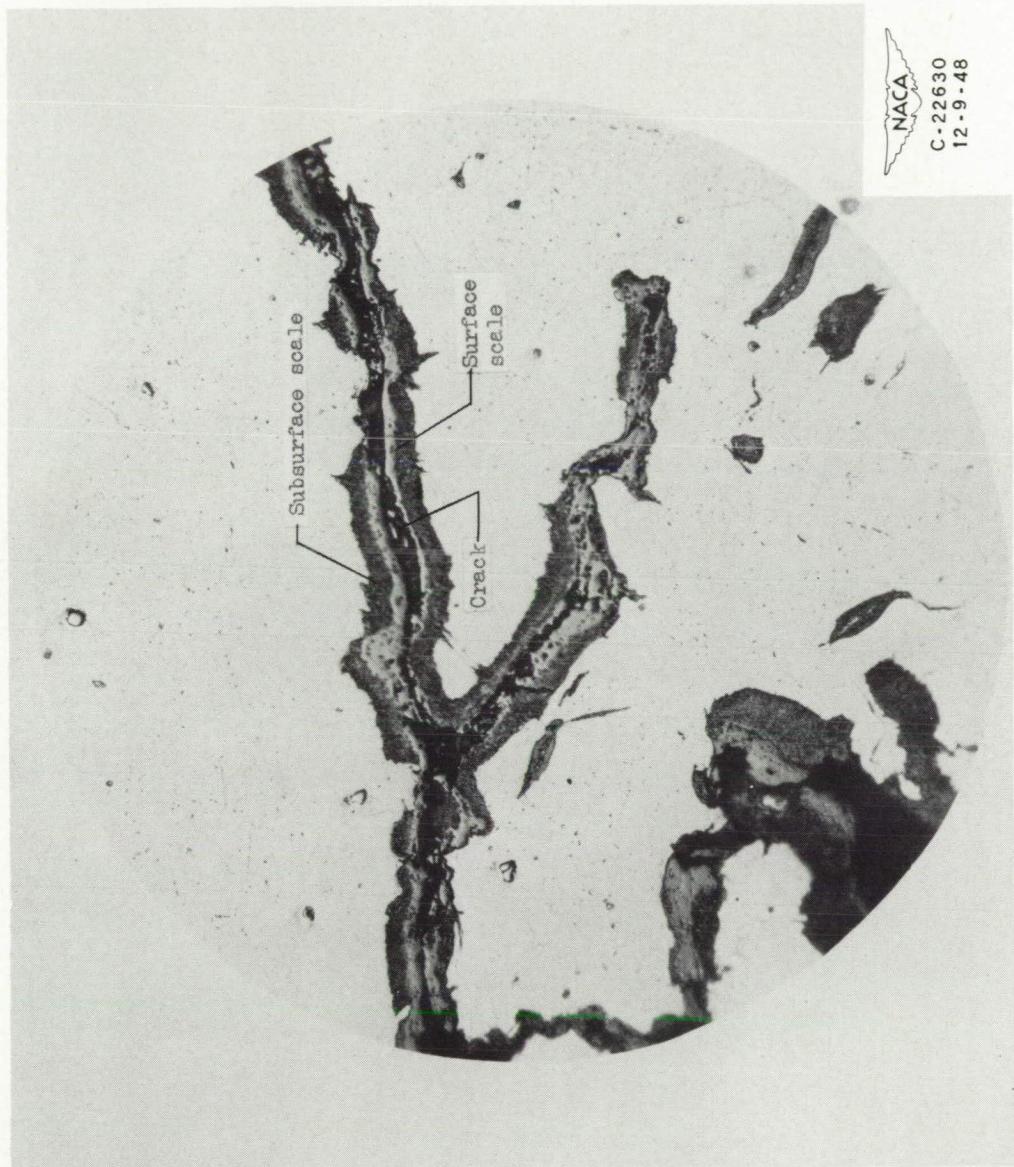
Figure 10. - Scale formations at crack. Type-B liner; etchant, 5-percent aqua regia in water, electrolytic; condition, cracked during accelerated-life determination; magnification, X500. Etchant has darkened subsurface scale zone. Scale almost appears to be two-phased because dark zone is dull purple and surface scale is gray.

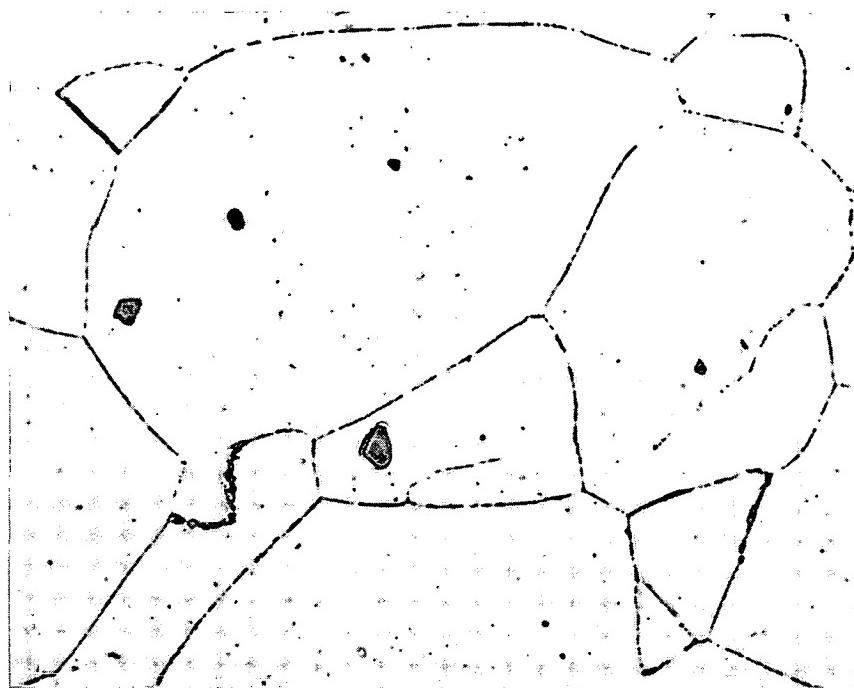
Trial heat treatments. - Heat treatment at 900° F produced no significant difference from the as-fabricated sample (figs. 15(a) and 15(b)). Heating at 1600° F caused precipitation of microconstituents, whereas heating at 2200° F dissolved most of these microconstituents (figs. 15(c) and 15(d)). In addition, heating at 2200° F softened the metal, caused grain growth, and aided recrystallization. No significant differences were observed between samples that were quenched in air or in water (table II).

(a) Not treated (dead soft).

(b) After heating at 900° F for 1 hour and air-cooling.

Figure 15. - Microstructure of dead-soft Inconel. Etchant, 10-percent sodium cyanide, electrolytic; magnification, X750.
